RICHELIEU RIVER BASIN
CHITTENDEN, VERMONT

CHITTENDEN DAM

VT 00178

PHASE I INSPECTION REPORT NATIONAL DAM INSPECTION PROGRAM

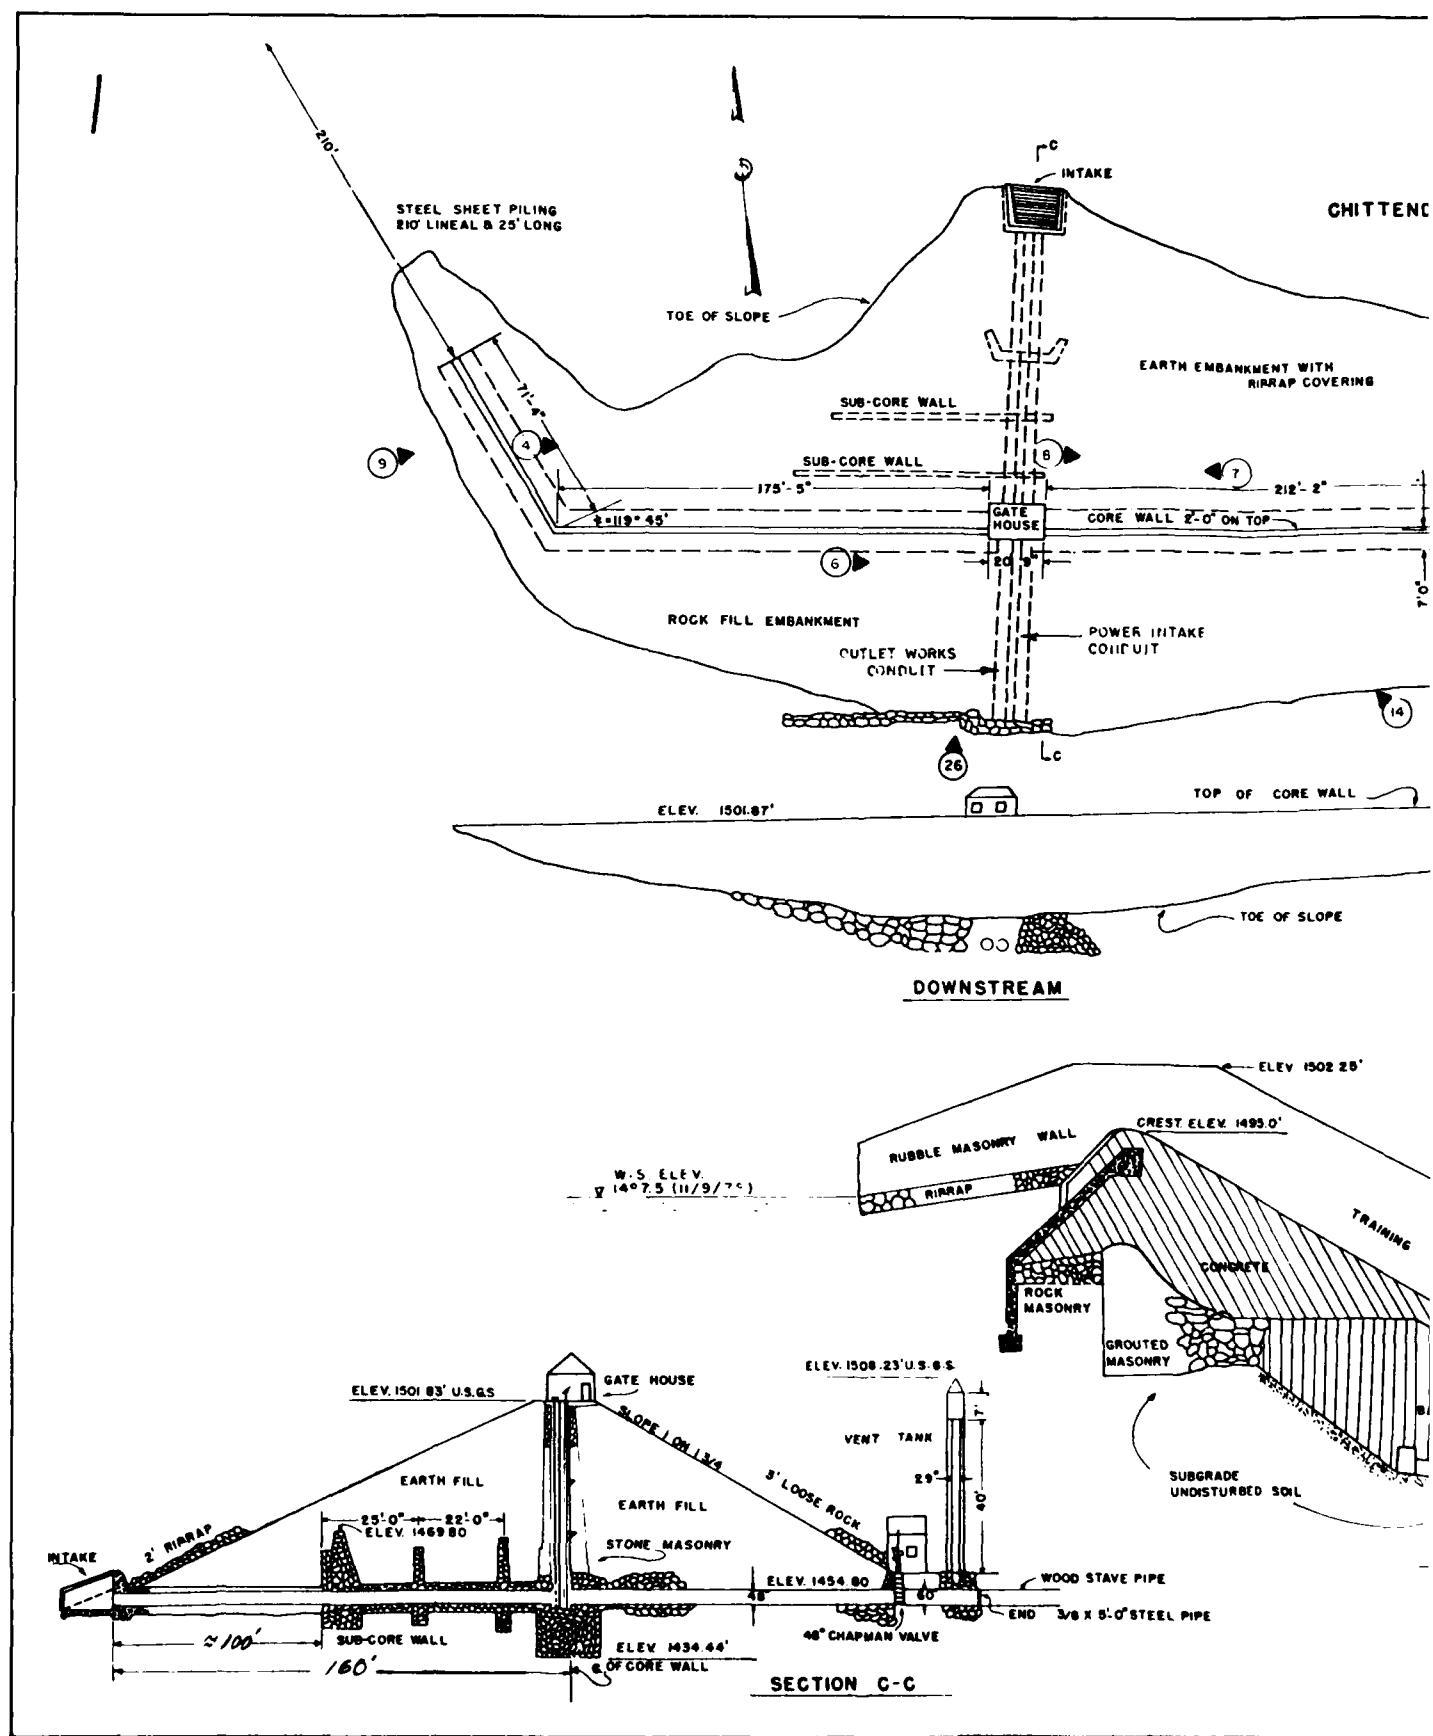
FIGURE 1

Figure 1, located in Appendix B, shows the plan of the dam and its appurtenant structures. Photographs of each structure are shown in Appendix C.
